Report of the Field Survey by Tokyo Tech Team after the April 25, 2015 Nepal Earthquake

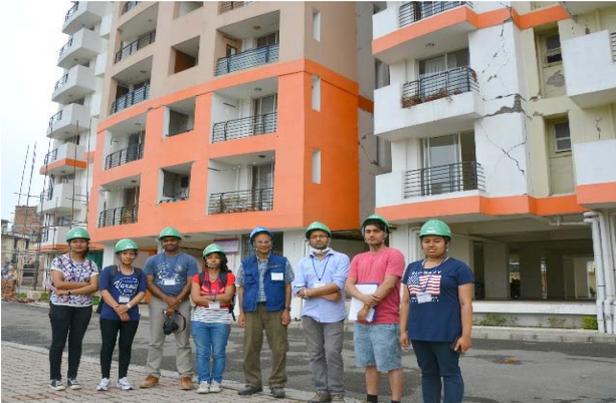
Fig. 3. Field survey team at a high-rise apartment building in Nakkhu, Lalitpur district which sustained significant non-structural damage.

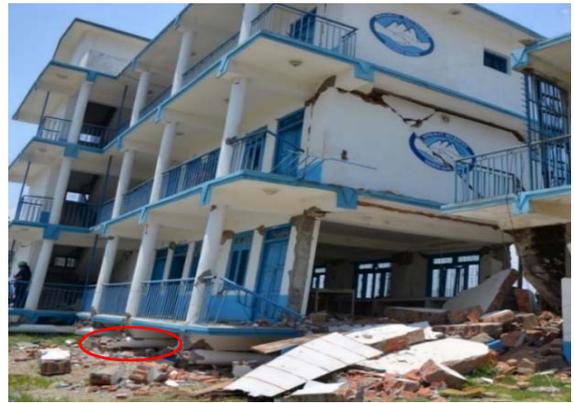
Fig. 4. Collapse of four-story school building in Sangachowk, Sindhupalchowk district. The collapsed first-story columns can be seen at ground level.

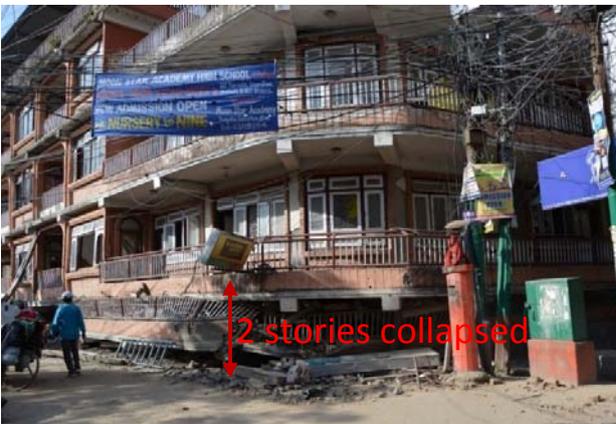
Fig. 5. Lower 2 stories of the building collapsed in Gongabu, Kathmandu district due to soft story effect.

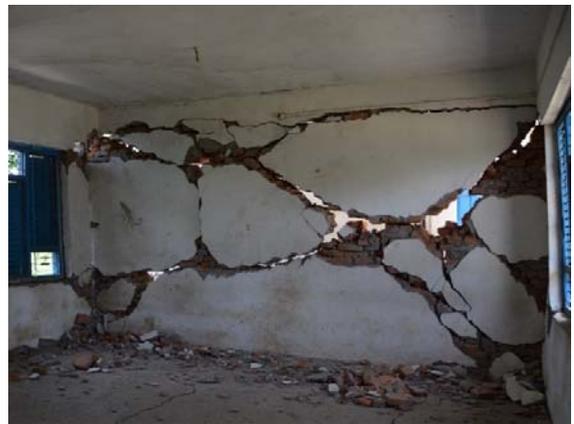
Fig. 6. Heavily damaged masonry infill wall of a school building in Sangachowk, Sindhupalchowk district.

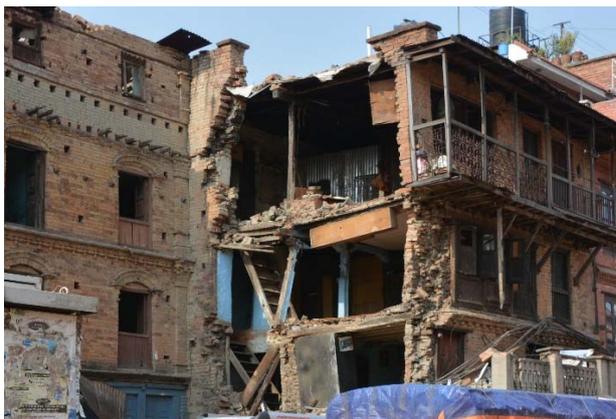
Fig. 7. Curtain fall collapse of entire side wall of partial load bearing masonry structure with timber columns near Bhaktapur Durbar Square area, Bhaktapur district.

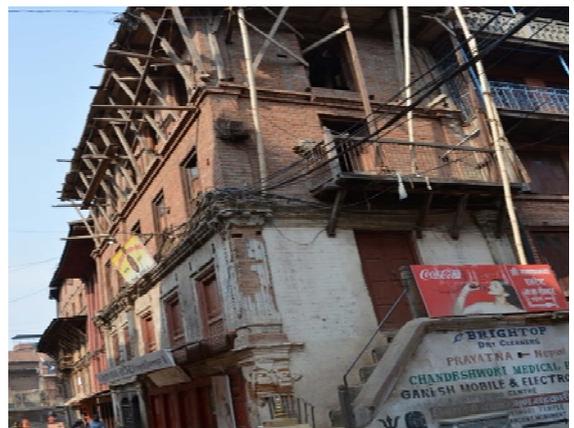
Fig. 8. Addition of extra stories over the existing old structure in Bhaktapur district and yet, no significant damage due to the earthquake was observed.

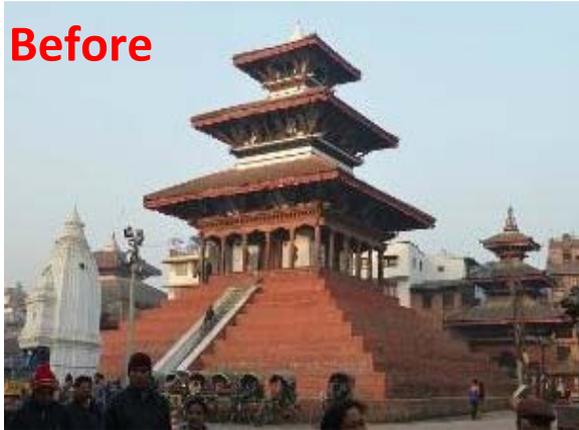
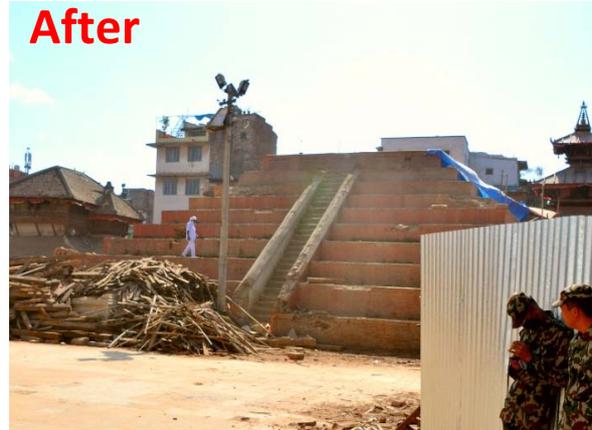
Fig. 9. Maju deval temple in Basantapur Durbar Square, Kathmandu district. The earthquake caused the three-story pagoda style temple to be reduced to rubble. However, the foundation and the stairway to the temple up to the plinth level is intact. The white-colored shikara style temple next to it is also completely damaged.

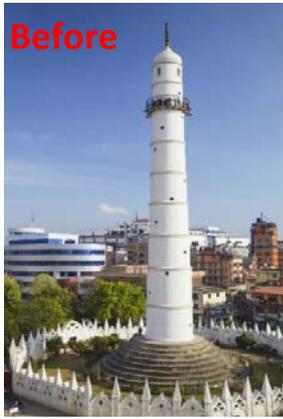
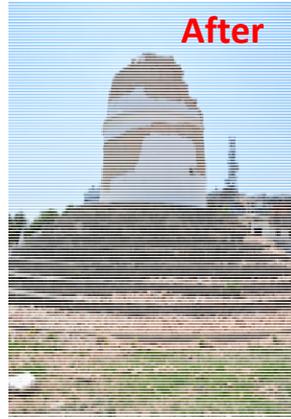
Fig. 10. The nine-story, historic landmark tower, Dharahara in Kathmandu district collapsed. 180 people lost their lives when the tower collapsed.

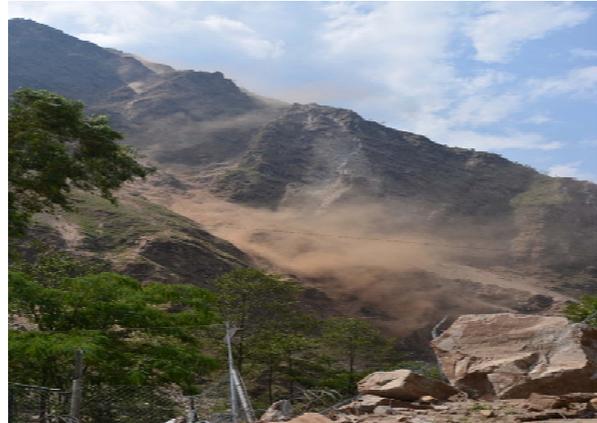
Fig. 11. Active landslide along Araniko highway between Dolalghat and Tatopani in Sindhupalchowk district.

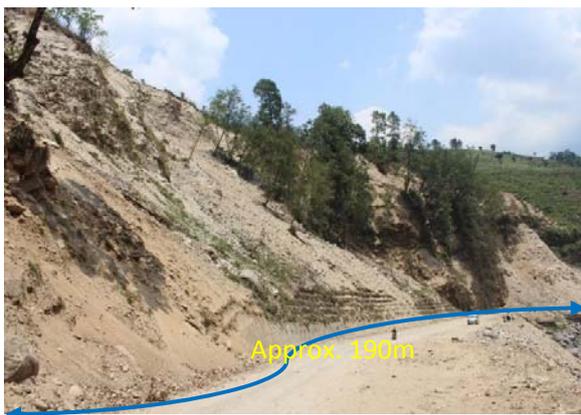
Fig. 12. Landslide near to Barahbishe, Sindhupalchowk district.

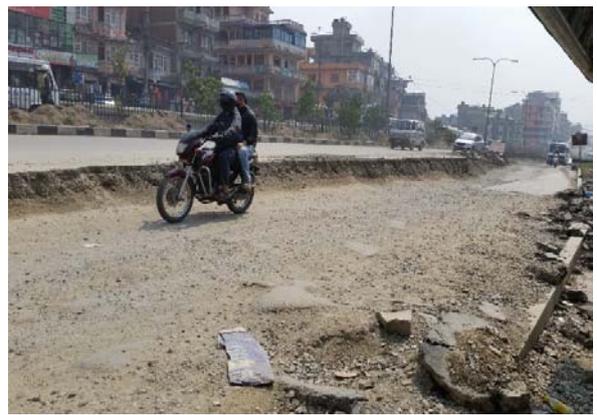
Fig. 13. Damage to Koteswor-Bhaktapur highway at a location near the Kaushaltar bus stop. Extent of separation of roadway as observed on June 03, 2015.

Damage to roads observed along the Koteswar-Bhaktapur road were mainly due to the [deformation](#)~~consolidation~~ of the soil beneath it. Some landslides that occurred along mountainous roads are unavoidable but can be minimized. Minor damage to structures due to geotechnical failures were observed, whereas rockfalls along the highway caused severe damage to buildings.

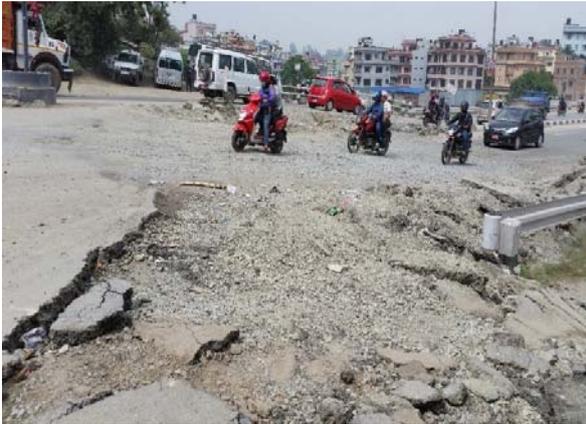
Fig. 14. Damage to Koteswor-Bhaktapur highway at a location near the Lokanthali bus stop, as observed on June 03, 2015.

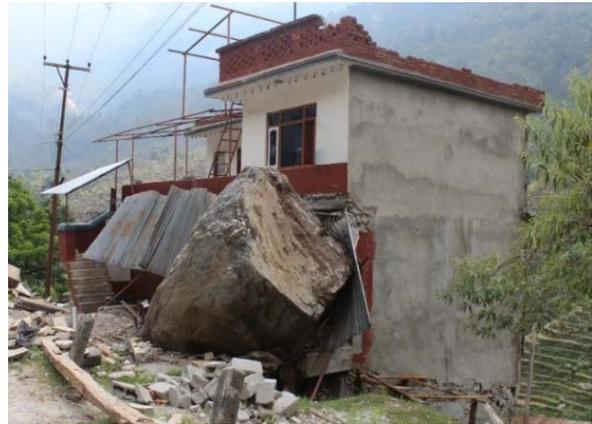
Fig. 15. Massive rock dislodged from a hill coming to rest against a reinforced concrete building, on Araniko Highway in Sindhupalchowk district.

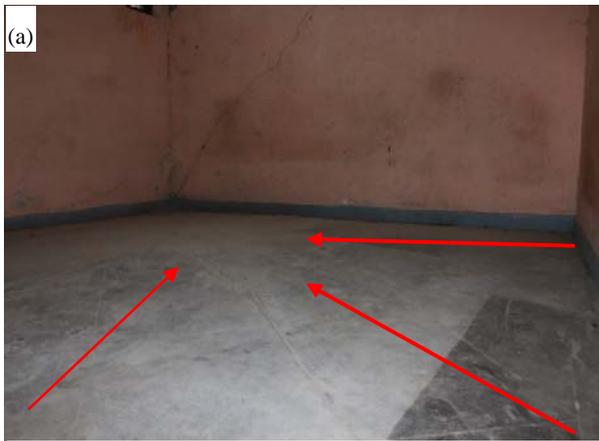
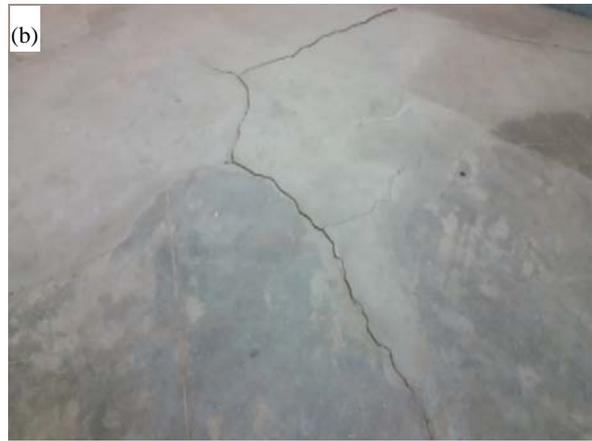
Fig. 16. Raised floor slab in a residential building in Manamaiju village, Kathmandu district. (a) The central part of the floor slab was bulging upwards. (b) Cracks on floor slab due to stress developed caused by deformation of foundation soils.
